# Use of non-destructive testing for the evaluation of the preservation state of Iquique Clock Tower, Chilean Historic Monument

## Utilización de técnicas no destructivas en la evaluación del estado de conservación de la Torre del Reloj de Iquique. Monumento Histórico Nacional de Chile

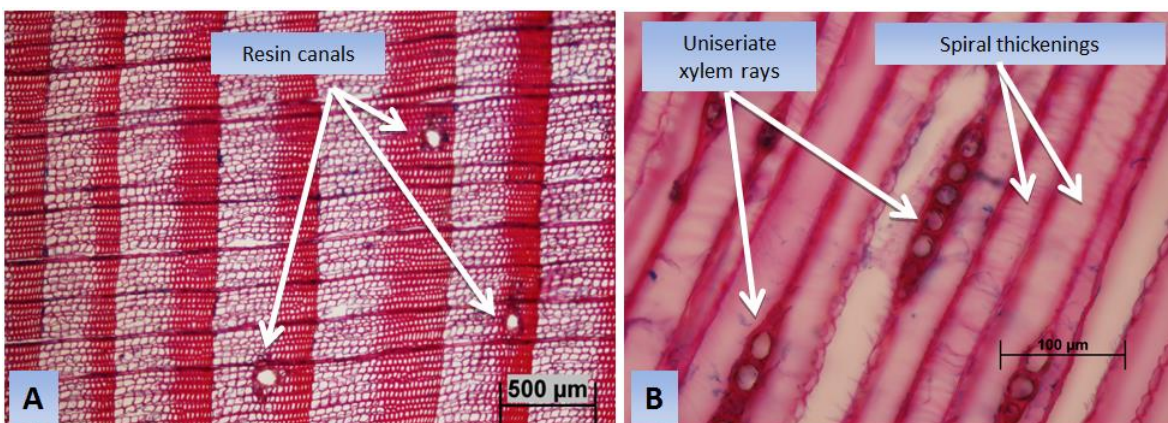
The results of the wood identification study determined that the fifteen samples collected correspond to the species *Pseudotsuga menziesii* (Oregon Pine). The presence of resin canals (Figure 2A), spiral thickening and uniseriate wood rays (Figure 2B) confirm this fact.

Figure 2. Optical microscopy from *Pseudotsuga menziesii*. A. Resin canals - B. Spiral thickenings and uniseriate xylem rays. Source: Self elaboration.

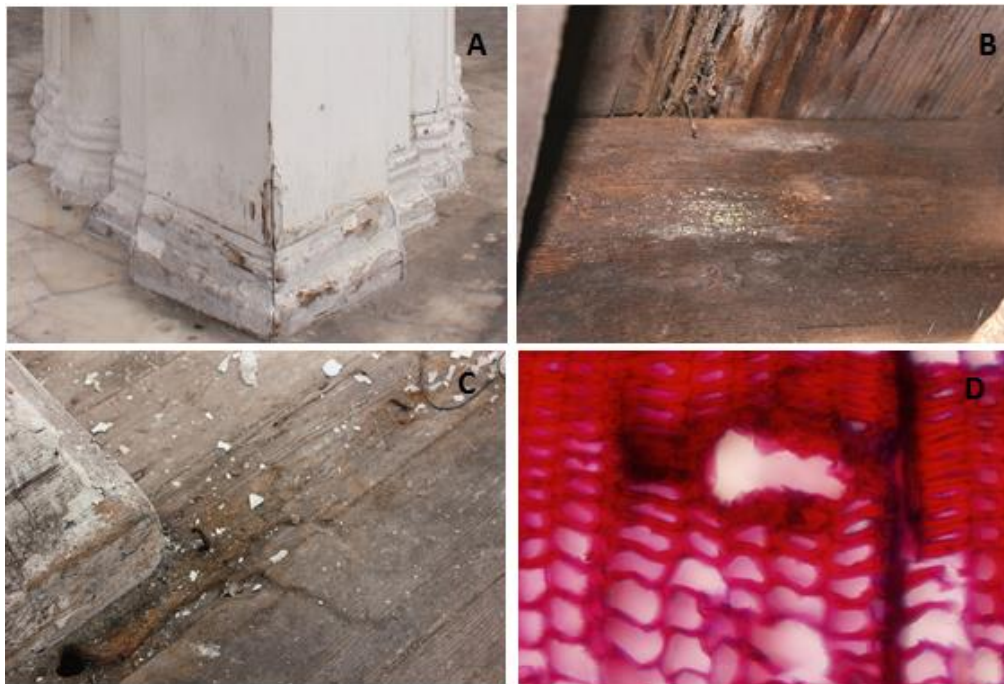
The studies of the basic inspection showed that the main part of the elements that comprise the building are healthy. However, there are some exceptions in the external lower part that show deterioration by the action of insects (Figure 3A) and there is some internal deterioration at the foundations level by rot (Figure 3B). Chemical degradation by defibrillation was also observed in the external upper levels (Figure 3C).

**Figure 3.** A. External deterioration by the action of social insects - B. Deterioration by rot – existence of fungal mycelium - C. Chemical degradation by superficial defibrillation - D. Brown rot in the wood of *Pseudotsuga menziesii*. Source: Self elaboration.

The results of the basic inspection do not show signs of deep damage. Deterioration by the action of larval cycle insects and social insects are evident and are apparently inactive. The deterioration by brown rot is consistent with the corresponding wood substrate of a conifer species (Schmidt, 2006), which is shown through the loss of the original shape of the cells due to the depolymerization of cellulose (Figure 3D). Regarding the degradation by defibration caused by the existence of salt in the environment, this is related to the proximity of the building to the coast of Iquique. This can be explained by the influence of the marine mass and the Humboldt current on the coastal desert climate of the city, which is presented with high humidity and low probability of rainfall. The defibration, as described in the literature, only causes a superficial degradation (Kučerová et al., 2008). Therefore, it does not present any risk for the integrity of the tower due to its shallow depth. The analysis of the results of the geometrical evaluation of the four facades determines that the deviations are minimum and negligible. The observed deviations are attributable to the construction process and it is ruled out that these are caused by external forces or by a resistant behavior.

The structural analysis determined that the working stresses do not exceed the admissible stresses. However, and facing the evident deterioration of the wood at the foundations level, it is necessary to perform intervention actions in the building.

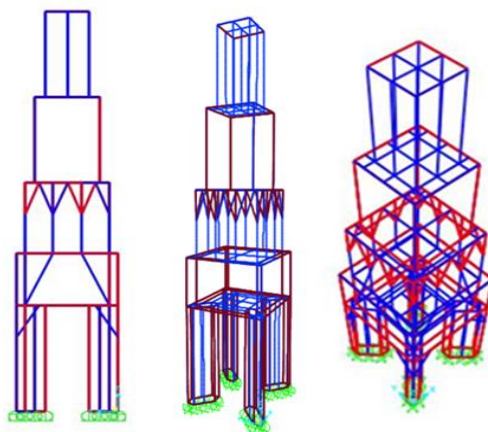
Figure 4 shows the structural modeling of the tower. The working stresses obtained through Sap 2000 and the admissible stresses, according to the Chilean regulations, of the most unfavorable elements in flexo-compression and shears are shown in Table 3. The results determined that the working stresses of the building are under the respective admissible stresses.

Figure 4. Structural modeling of the Iquique Clock Tower. Source: SAP2000 v20.

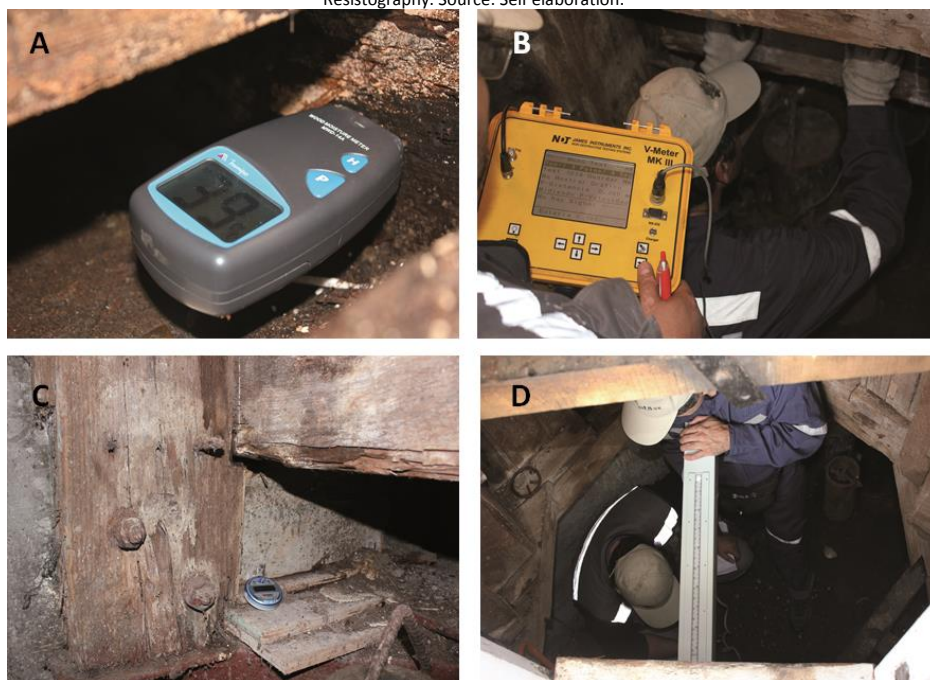
The values of moisture content of wood, with the exception of the fourth level (22%), are close to the Fibre Saturation Point (FSP) so there is a high probability that the material can reach the condition of liquid water inside the cell cavity. According to the recorded values of temperature and relative humidity, the equilibrium moisture content of wood should be around 15% (Table 1) (Kollman, 1959). The results show a significant difference between the wood moisture contents and the values of equilibrium moisture content, according to the estimates performed based on the prevailing environmental conditions on each of the building levels. This difference can be explained due to the existence of moisture sources, other than the environment, related to constructions adjacent to the tower and that are not properly waterproofed, thus allowing the entry of water at the foundations level. This favors the biodeterioration conditions.

The value of ultrasonic wave propagation speed, at a longitudinal direction, and at 13.6% of moisture content for the wood of *Pseudotsuga menziesii* corresponds to 4706 m/s (Niemz et al. 1994). The results obtained in the evaluation, for the mezzanine and second level, determined slightly higher and slightly lower longitudinal speed values in relation to what was reported by Niemz et al (1994). This establishes that, for the mezzanine and second level, the wood is healthy. However, the speed measured at the foundation level indicates that the wood has lost at least 50% of its mechanical strength (Ross & Hunt, 2000).

NDT integration with respect to moisture content values (Figure 5A, 5C), ultrasound speed (5B) and normal density obtained through resistography (5D) allow estimating the static MOE in bending. The evident decrease in wood density is reflected in a low MOE value. The aforementioned considerations are the basis for structural classification, being F3 the lowest category in the Chilean regulation. Notwithstanding the above, the structural formation and the low weight of the tower have contributed to a proper behavior to seismic requirements to which the building has been subject. Although the working stresses do not exceed the admissible stresses, it is important to mention that some elements at the foundations level are severely affected by biodeterioration agents. The evident decrease in the mechanical properties of these elements is worrisome. Therefore, performing intervention actions immediately in order not to jeopardize its stability is required.

**Figure 5.** NDT integration in the clock tower: A. Wood hygrometry - B. Ultrasonic wave propagation speed - C. Sensors of temperature and relative humidity - D. Resistography. Source: Self elaboration.
