Impact analysis of geotechnical occurrences in EPC projects cost control

Manuscript Code: 1157

DOI: 10.7764/RDLC.18.3.418

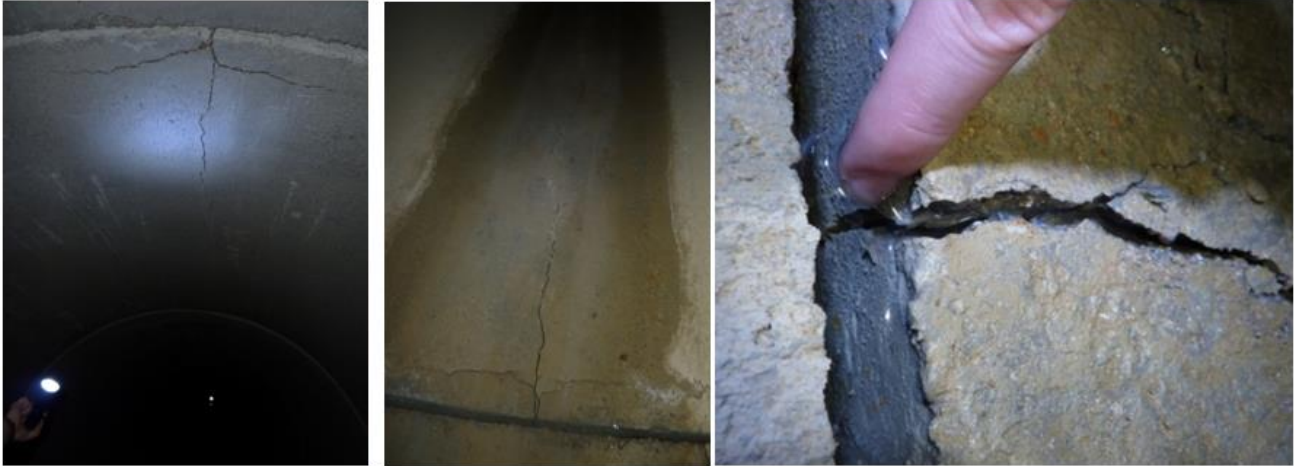
Figure 2. Observed damage. Source: Own elaboration (2017).

The pluvial water collector object of this research is made of reinforced concrete (250 mm thick) and it extends in the solar plant from north to south (1500 m in length and with a maximum depth of 15 m). The first section of about 620 m has a diameter of 1800 mm, while the second section of about 880 m has a diameter of 2500 mm. Along 400 m of the latter section; longitudinal cracks were detected on the walls of the concrete pipe shortly after its construction but before its commissioning.

This pipe has very unusual characteristics, not because of the 2500 mm diameter but because of a filling of up to 15 m in its most unfavourable section, being about 12 m for the majority of its path. Therefore, its design was based on the

The pathologies found in the pipe appeared in the form of interior longitudinal cracks, both at the crown and the invert of the pipe (Figure 2).

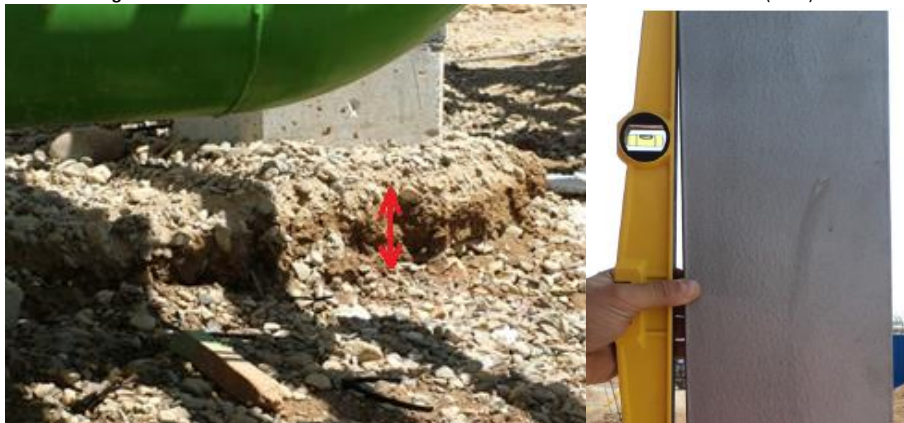
Figure 3. Mud Thickener settlement and vertical deformation. Source: Own elaboration (2018).

Nevertheless, during the commissioning of the facility, some equipment showed settlements that were much higher than the established limits, which led to a temporary shutdown of the facility. Those settlements had an immediate effect in the supported structures, leading to excessive deflections and reaching dangerous inclinations, as can be seen in Figure 3.

The subsidence phenomena have been previously documented in Southern Spain (Herrera, Fernández, Tomás, Cooksley, & Mulas, 2009), so, in order to solve this unforeseen issue, the engineering team was involved again in the process.

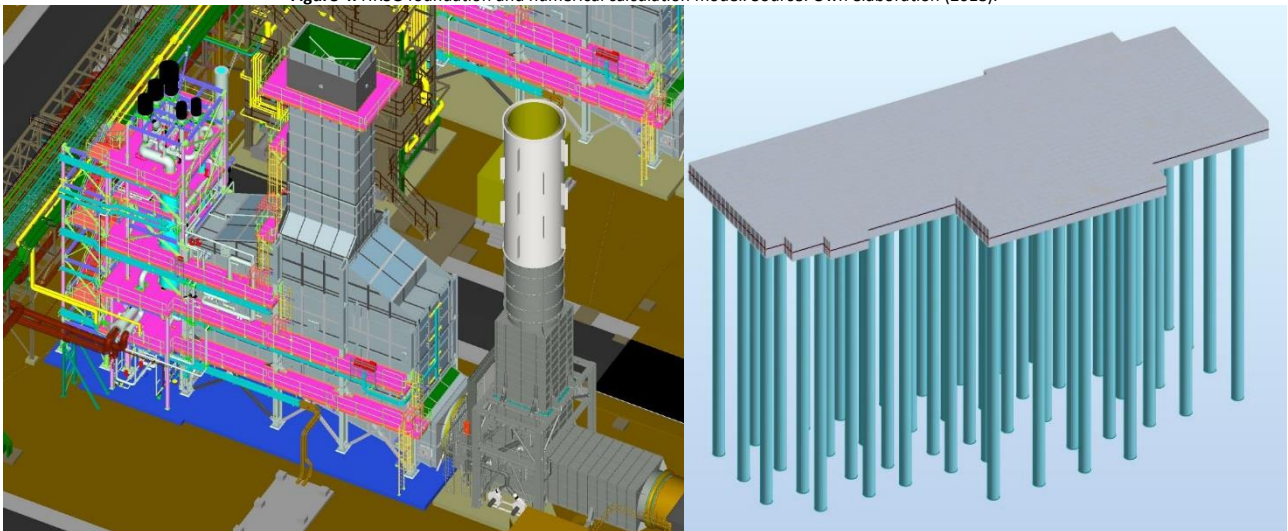
Figure 4. HRSG foundation and numerical calculation model. Source: Own elaboration (2018).

In order to develop a consistent analysis, a real construction case will be explained. It consists of deep foundation design, in a soil with high liquefaction potential, along the construction of a natural gas combined cycle power plant in Bangladesh. This case consists of the HRSG (Heat Recovery Steam Generator) boiler foundation (Figure 4). The boiler is founded in a sandy, water-saturated soil, potentially liquefiable, by means of deep foundations.

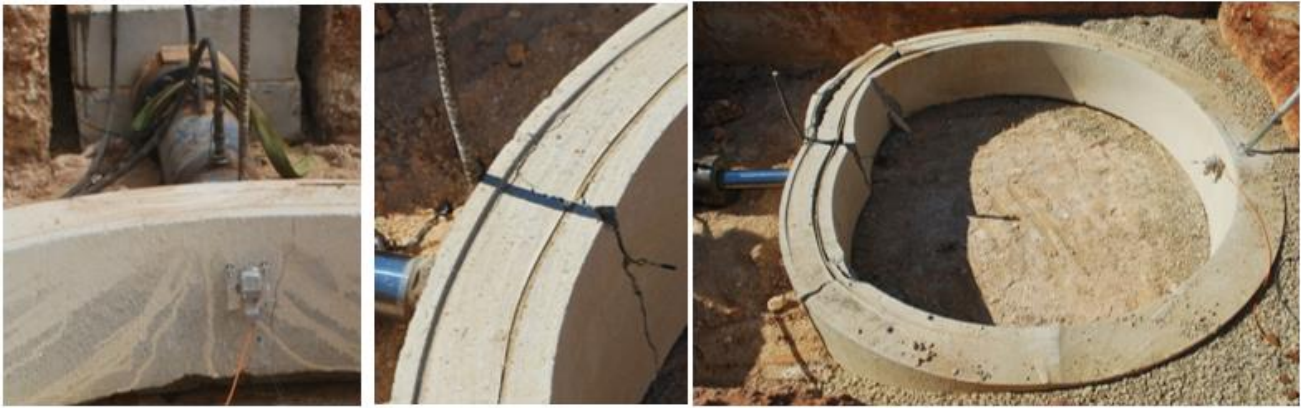
Figure 5. Pipe In situ tests. Source: Own elaboration (2018).

In order to evaluate the damage, several in situ tests were carried out. Some sections of the pipe were dug up, so the surrounding soil could be characterized.

Simultaneously, some pipe rings were tested within situ load tests, in order to evaluate its real resistance (Figure 5).

From the in situ tests, a series of numerical models were developed, in order to evaluate the long-term stability of the pipe and to develop a bench test to check different solutions.

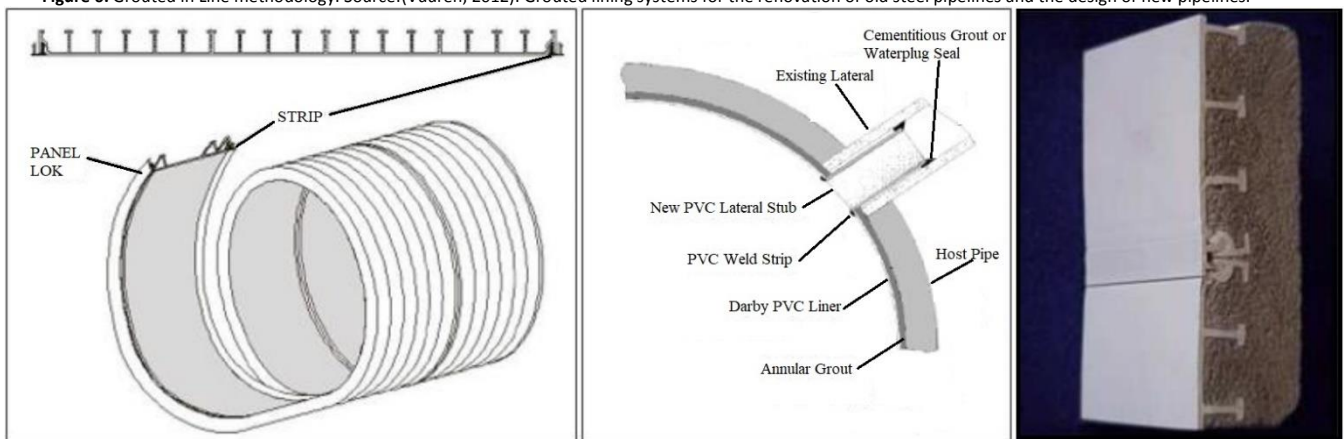
Figure 6. Grouted in Line methodology. Source:(Vuuren, 2012). Grouted lining systems for the renovation of old steel pipelines and the design of new pipelines.

The correlation between the in-situ tests and the numerical results let us establish as a solution the application of GIPL (Grouted In Place Linner) (Vuuren, 2012) methodology to the damaged section of the pipe. This solution increased the pipe wall thickness and in consequence, its maximum load resistance. The planned grout thickness, in this case, was 50 mm. This solution involved a PVC profile adjusted to the pipe inner wall and filled with grout as can be observed in the following picture (Figure 6).

From a structural point of view, this system represents a structural rehabilitation system classified as TYPE I according to the established criteria in the “Sewerage Rehabilitation Manual” published periodically by the Water Research Council (WRC, 2001) over the last 25 years.

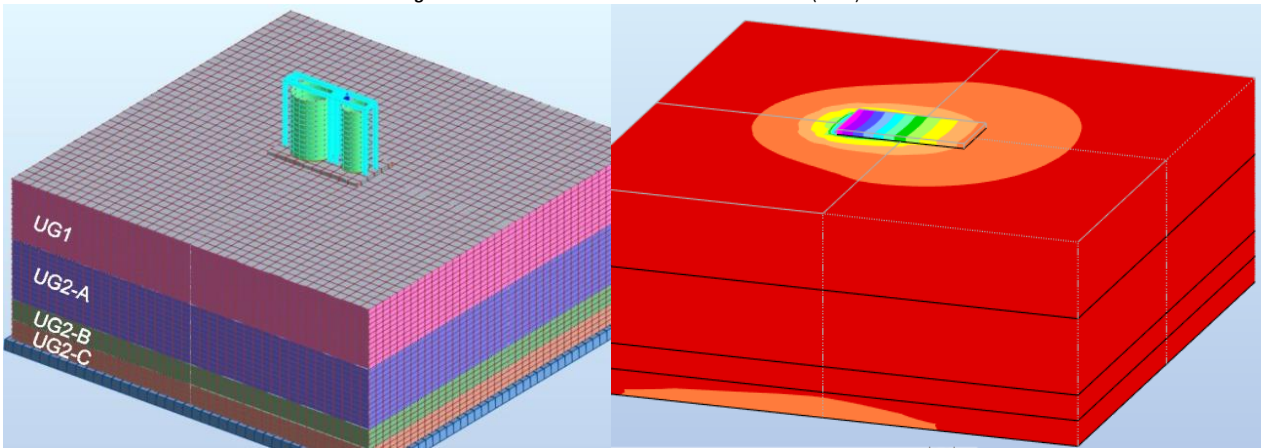
Figure 7. Numerical models. Source: Own elaboration (2018).

Once all data was collected, several numerical models were developed in order to ensure the stability of the structure and to crosscheck the original calculation's inputs (Figure 7).

From the models, two possible solutions can be applied:

- Improving the current foundation slab by use of micro piles.
- Improving the soil bearing resistance by use of a soil improvement treatment. This can be done by means of repetitive and selective mortar injections.

After consulting several companies specializing in deep foundation execution, the use of micro piles was rejected due to the difficulty in ensuring the final top of the concrete level for the whole slab. Additionally, the thickness of the executed slab would not have enough bend resistance if it was micro piled in the perimeter. Furthermore, it was impossible to position the micro piling machinery in order to execute micro piles in the middle of the slab.

Henceforth, the executed treatment consisted of soil improvement by means of 27 mortar injections in several phases (Cuéllar, 2004).
