Static load behavior and energy absorption of safety guardrails for construction works

Alfonso Cobo Escamilla (Main and Contact Author)

Technical University of Madrid, Department of Building Technology.
Escuela Técnica Superior de Edificación. Avda. Juan de Herrera, 6, 28040 Madrid (SPAIN)
alfonso.cobo@upm.es

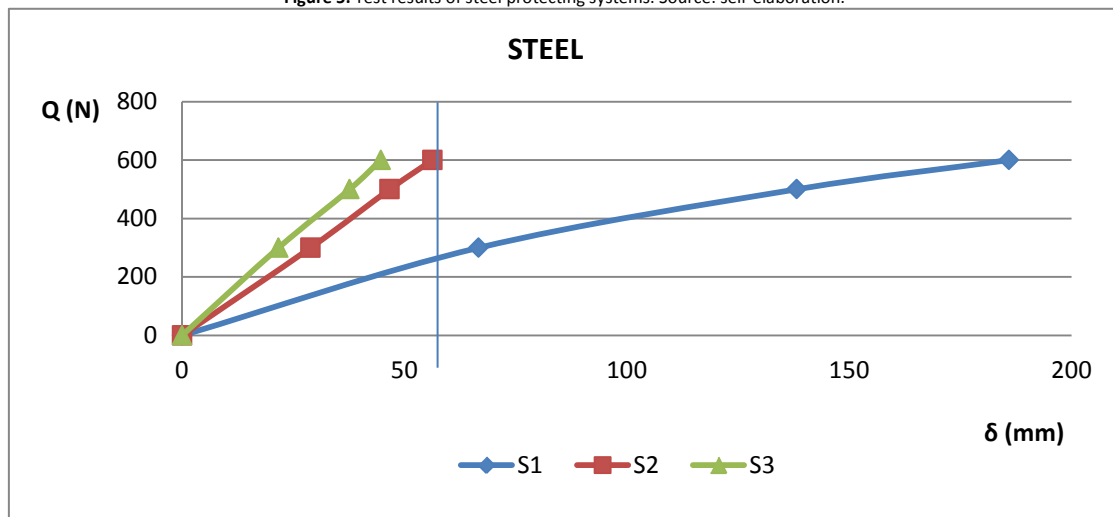
All systems correctly met the accidental load testing requirements. The behavior of all the systems studied when reaching the ultimate strength can be seen in figures 5-9, with the load applied at the central point of the top rail. A vertical line coincident with the 55 mm displacement is marked in all the graphs showing the maximum limit allowed in SLS tests by the EN 13374 standard when applying a 300N load.

Figure 5. Test results of steel protecting systems. Source: self-elaboration.

In the steel systems, railings consisting of 25·1.5 tubes (the most commonly used solution) experienced a displacement of 66.7 mm during the displacement test. S2 and S3 systems were able to satisfactorily overcome the assessment (table 3 and figure 5). Regarding wooden systems, the ones of 30 mm thickness are the only ones that exceed the standard requirements in any quality, and 27 mm thickness ones in ME1 quality (table 3 and figures 6, 7 and 8). In relation to the plastic systems, fences built with HDPE experienced large displacements, well above the 55 mm permitted. Aging has not affected the behavior in any of the tested systems. The addition of 4 % glass fiber conform a more rigid material (S16) which is able to pass the bending test (table 3 and figure 9).

All systems were able to satisfactorily meet the ULS test requirements. However, the behavior of the systems has been very different. Within the steel systems, system S1 shows a linear behavior until a 400 N load is applied. From that specific load value, non-linear deformations occur with a gradual loss of rigidity. The other systems have a practically linear behavior until they reach the ultimate limit state. All wooden systems show a linear behavior until they reach the ultimate limit state, regardless of the quality of the wood used and the thickness.

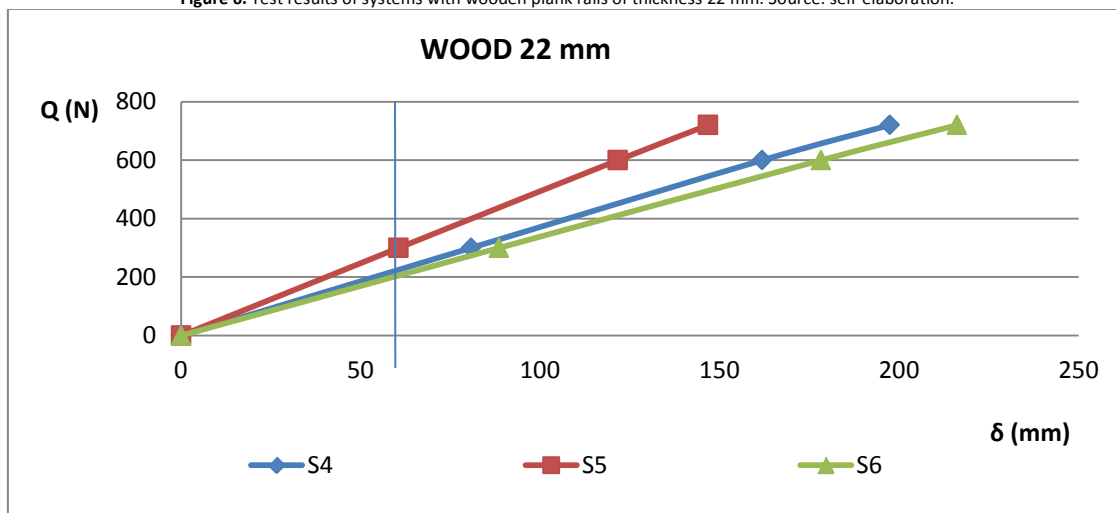
Figure 6. Test results of systems with wooden plank rails of thickness 22 mm. Source: self-elaboration.

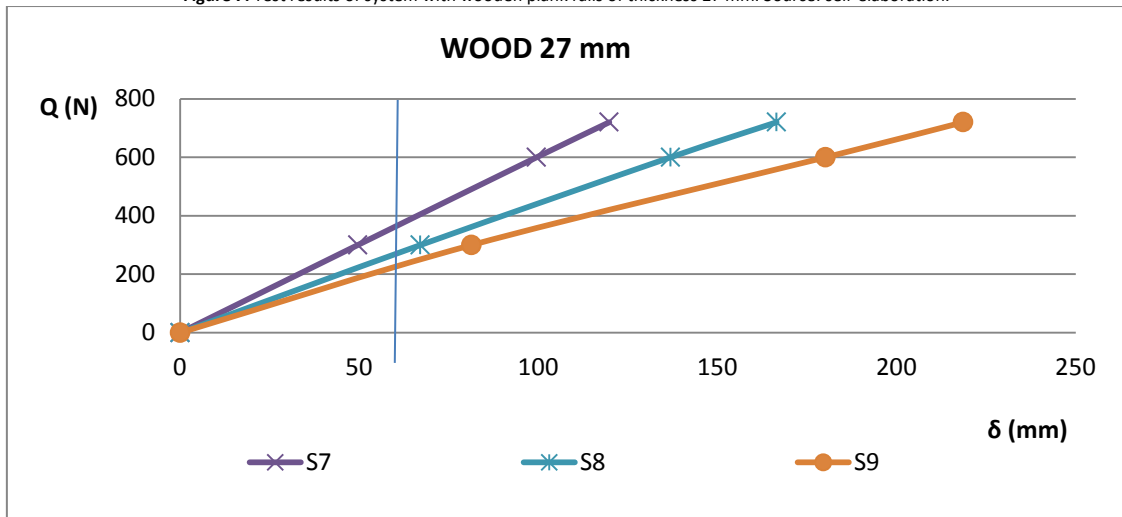
Figure 7. Test results of system with wooden plank rails of thickness 27 mm. Source: self-elaboration.

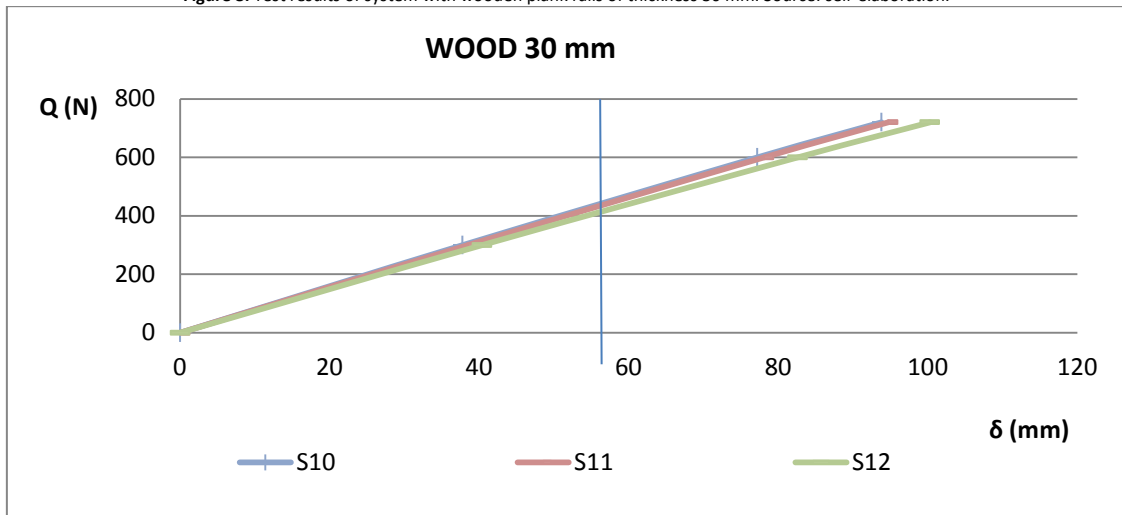
Figure 8. Test results of system with wooden plank rails of thickness 30 mm. Source: self-elaboration.

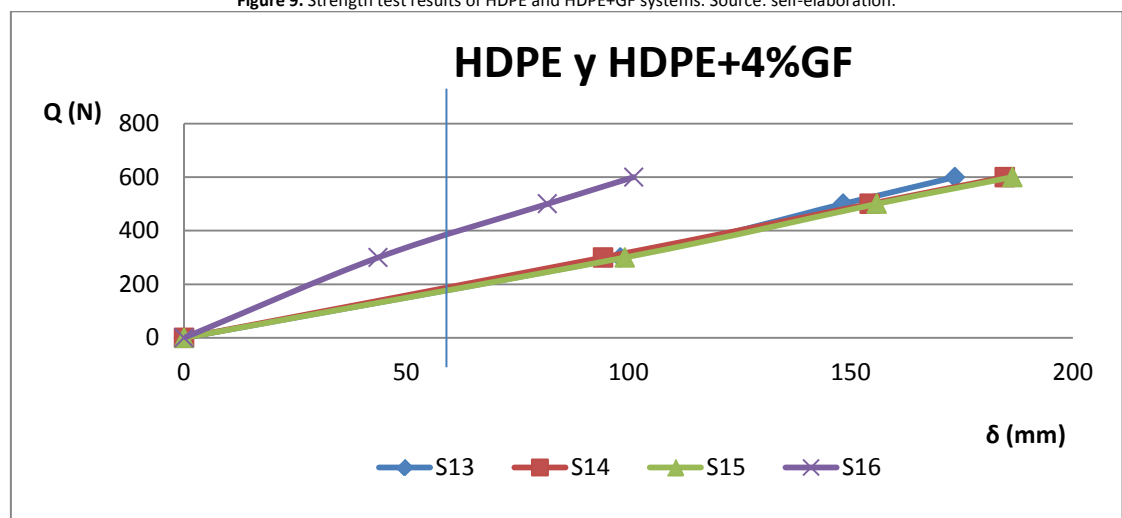
Figure 9. Strength test results of HDPE and HDPE+GF systems. Source: self-elaboration.

The four systems manufactured in HDPE show a very linear behavior until a load of 300 N is applied. From that value onwards, systems with no addition of glass fiber show a slight stiffening when subjected to load increases. Conversely, systems with glass fiber addition lose rigidity as the load increases. This highlights the great difference in stiffness of HDPE+GF TEPS when compared to the HDPE as can be seen in the descending curve of the graph (Figure 9). All the four tested systems are able to reach the established test load.
